# Manhole Inspection Summary

Manhole # S37AA1013MH

Insp Date: **1/2/07 10:53 AM**

**Location** Address: **3331 GREENMOUNT AVE**

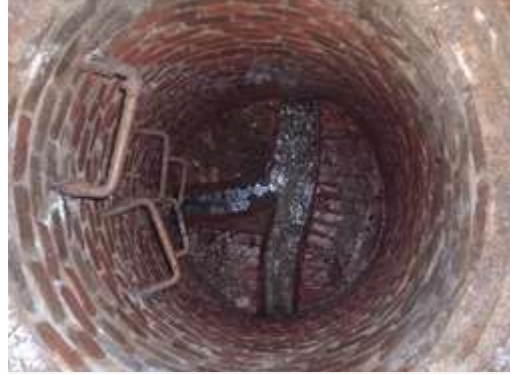
Top View

Corroded steps. Evidence of surcharge - Bench debris. Channel debris.

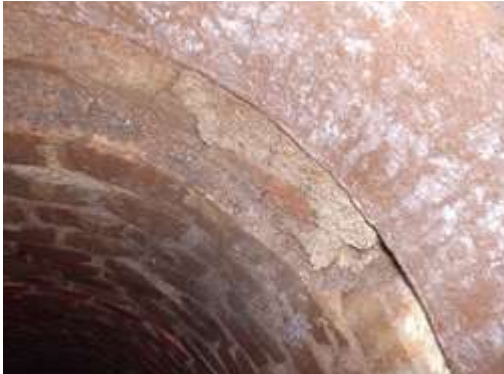
Defect

☒ **Leaks**

Condition: ☐ Sound ☐ Cracked ☐ Root Intrusion ☐ Loose Brick ☒ **Deteriorated**

Infiltration: ☐ None ☒ **Joint** ☐ Cracks ☐ Mortar ☐ Roots ☒ **Wall**

Frame leaks. Adjustment deterioration and infiltration.

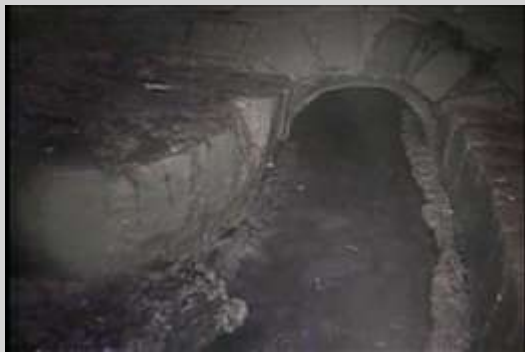
Pipe Out @ 12 O'Clock

Channel debris - Grease deposits.

Deposits: ☐ None ☐ **Mud** ☐ Sludge ☐ **Debris** ☒ **Grease**

Silt Depth: **0** (in.) Deposits Extent: **Light**

Infiltration: **Evidence** Pipe Seal Cond: **Unknown**
